The
San Francisco Earthquake and Fire

A BRIEF HISTORY OF THE DISASTER

A Presentation of Facts and Resulting Phenomena, with Special
Reference to the Efficiency of Building Materials
Lessons of the Disaster

A. L. A. HIMMELWRIGHT, C.E.

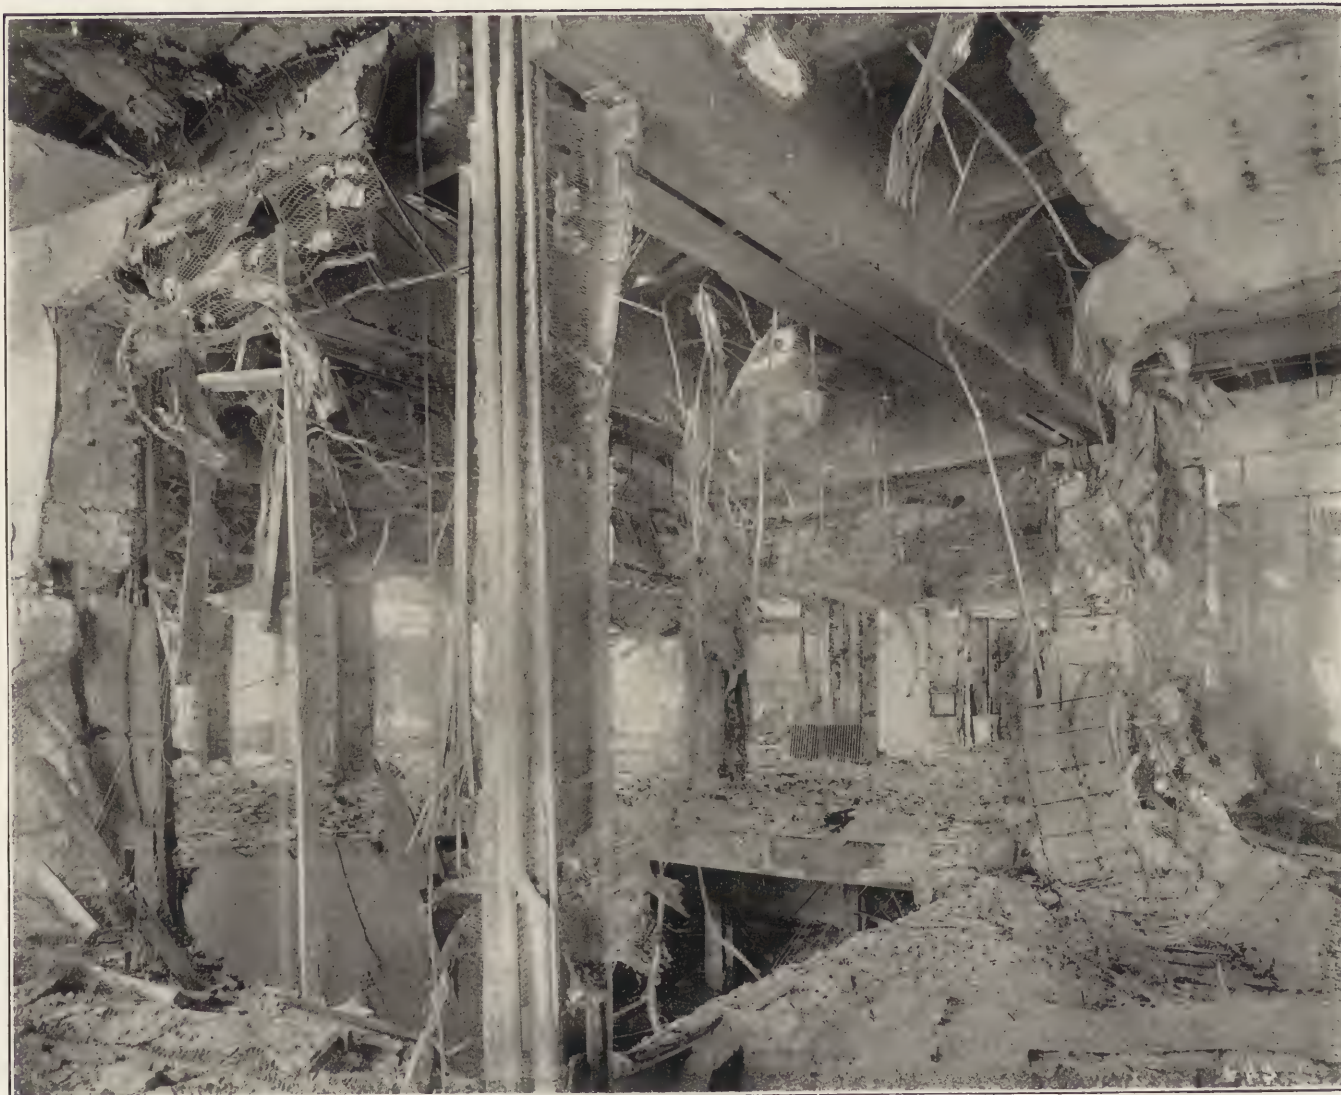
MONADNOCK BUILDING. First Floor. Showing the effect of dynamiting. One complete bay was entirely disrupted, the steel connections of the beams and girders being broken, allowing the mass to fall into the basement and wrecking the expanded metal lath and plaster ceiling of the floor directly above it.

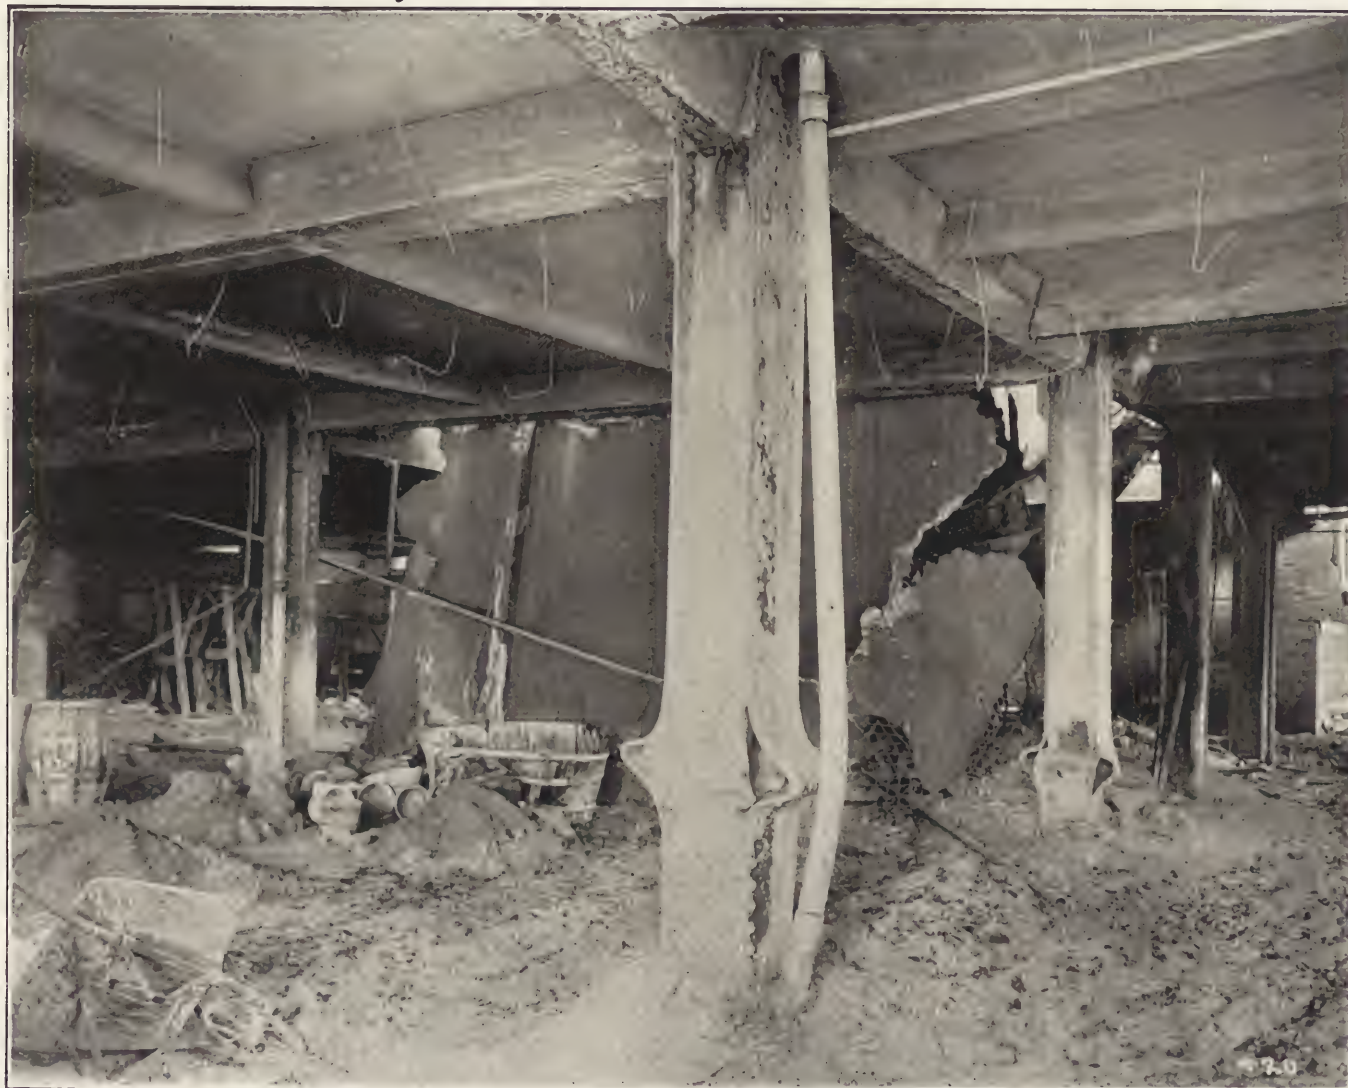
In the basement story where the column protection had not yet been placed, a pile of lumber for scaffolding caused the buckling of two columns and the deflection of some steel beams and girders that were exposed. A charge of dynamite on the west side of this building disrupted an entire bay between four columns of the first floor, breaking the connections of the beams and girders at the columns and causing the entire floor section to drop to the basement. The wire lath and plaster ceiling of the third story, immediately above this bay, was also destroyed, portions hanging in shreds by the original fastenings. Three reinforced concrete beams adjacent to the bay that was destroyed by dynamite, are badly shattered. The steel girders and concrete protection around them, which support the reinforced concrete beams, although nearer to the disrupted bay, are uninjured. The dynamiting also caused considerable damage to other portions of the work on this side of the building.

MONADNOCK BUILDING. Basement Story. Showing buckled columns caused by the burning of scaffolding lumber piled around them. The bay of floor construction standing on edge in the centre was broken out by dynamite. The building was in the course of construction, and the protection of the columns had not yet been placed.

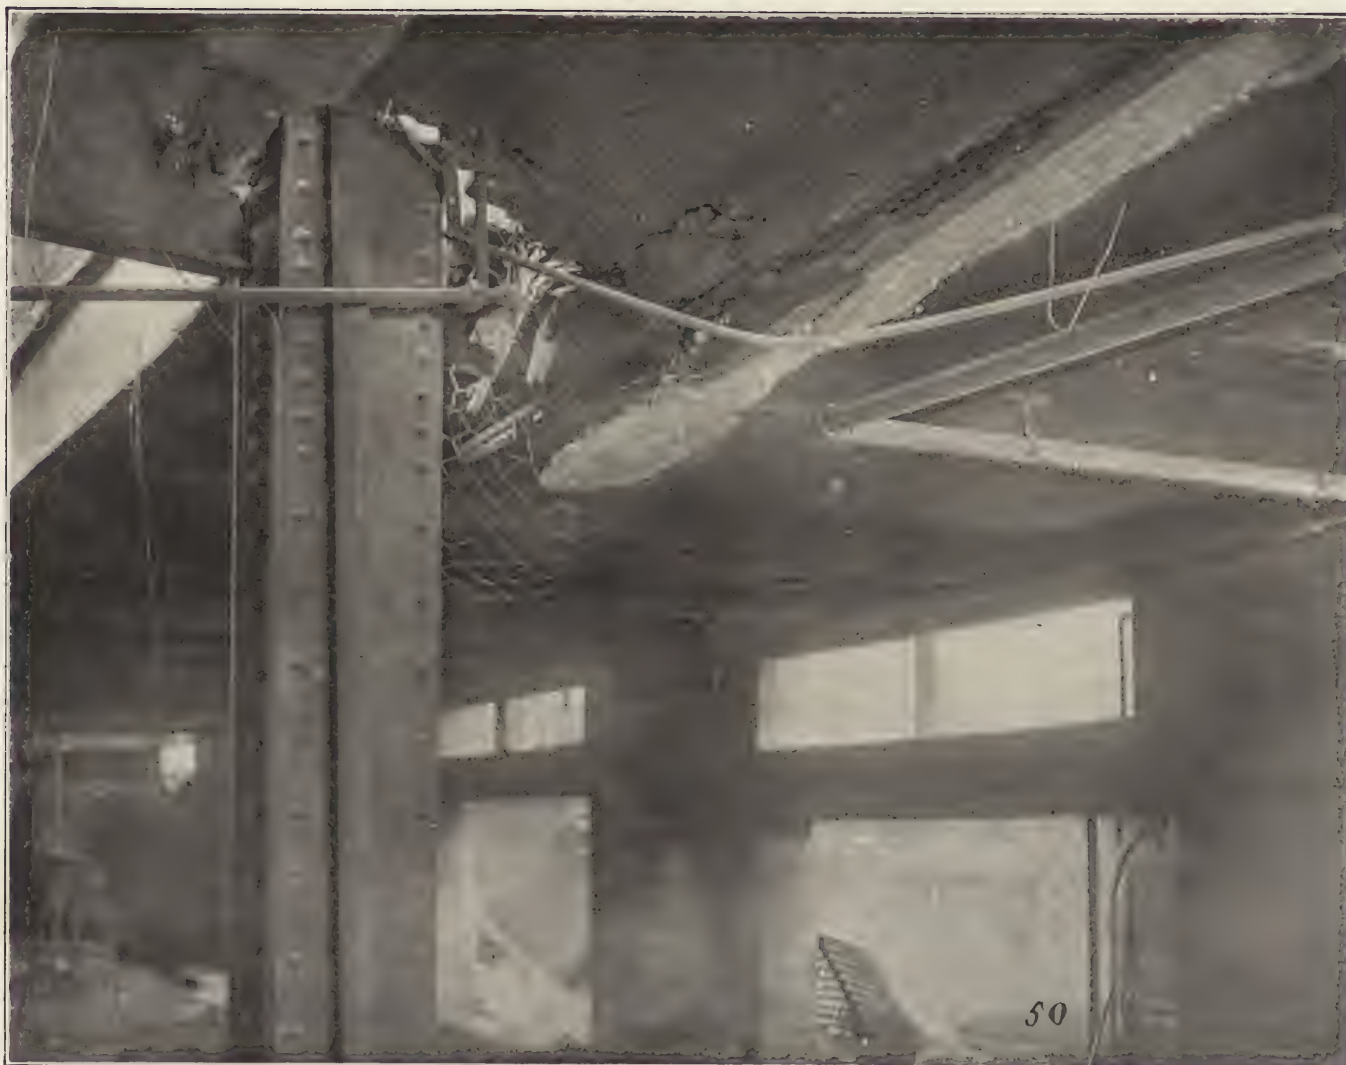
MONADNOCK BUILDING. Basement Story. Showing the damage to reinforced concrete beams adjacent to the bay that was disrupted by dynamite.

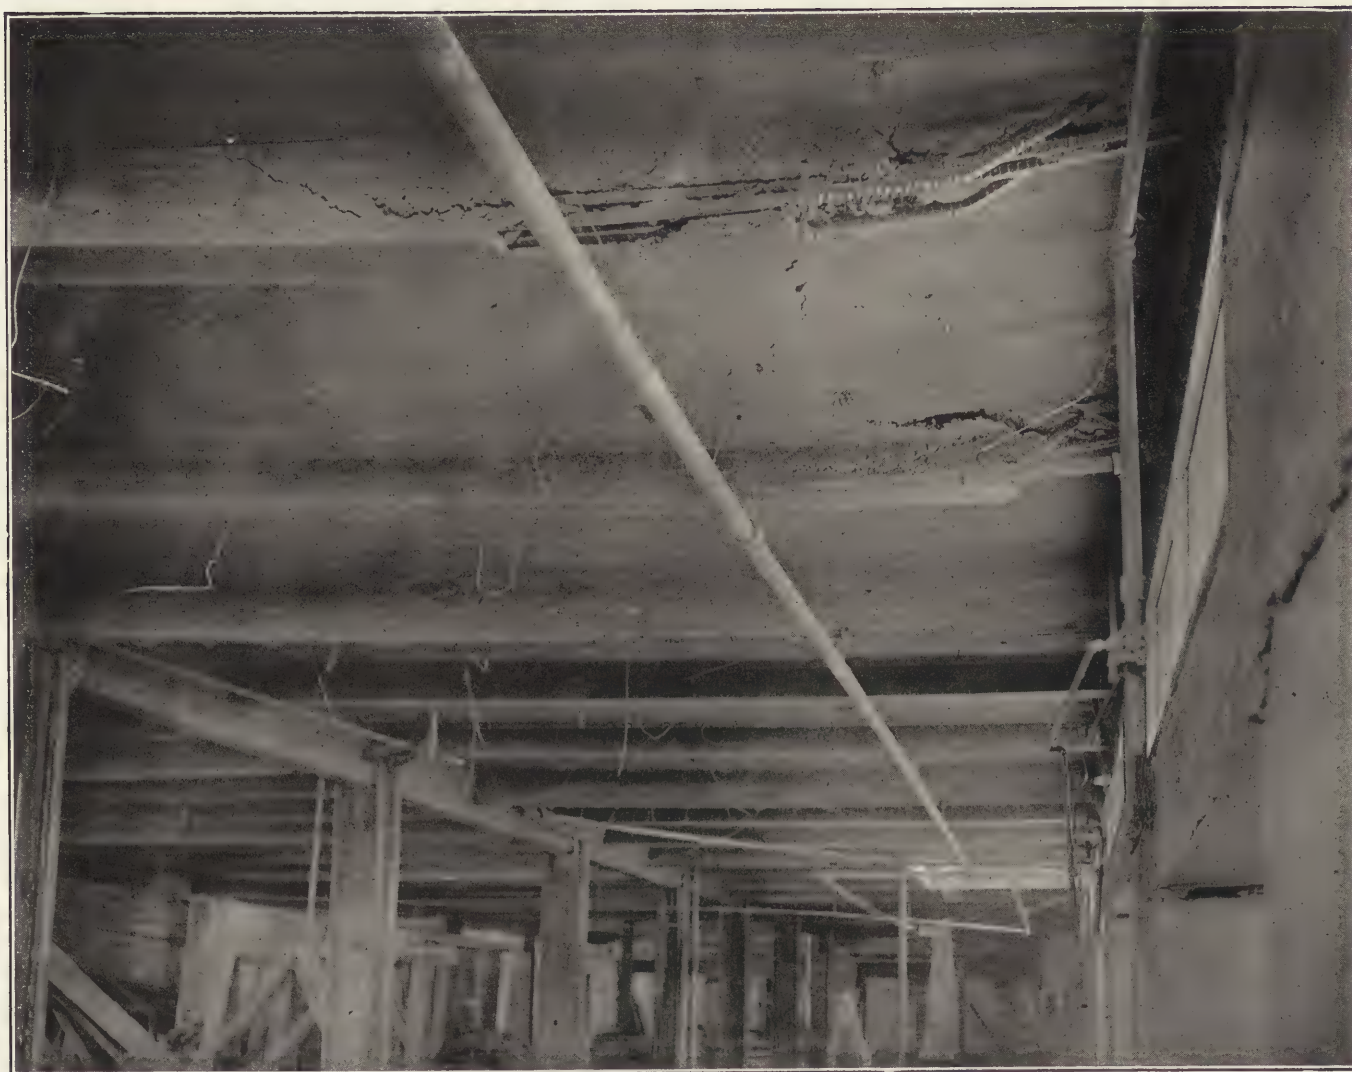
MONADNOCK BUILDING. Basement Story. Showing the failure of reinforced concrete beams and flooring near the southwest corner of the building. The other ends of the reinforced concrete beams in the foreground are supported by a girder adjacent to the bay which was blown out by dynamite. Whether caused by dynamiting or by earthquake, the damage to the floors would probably have been much less had steel beams been used.

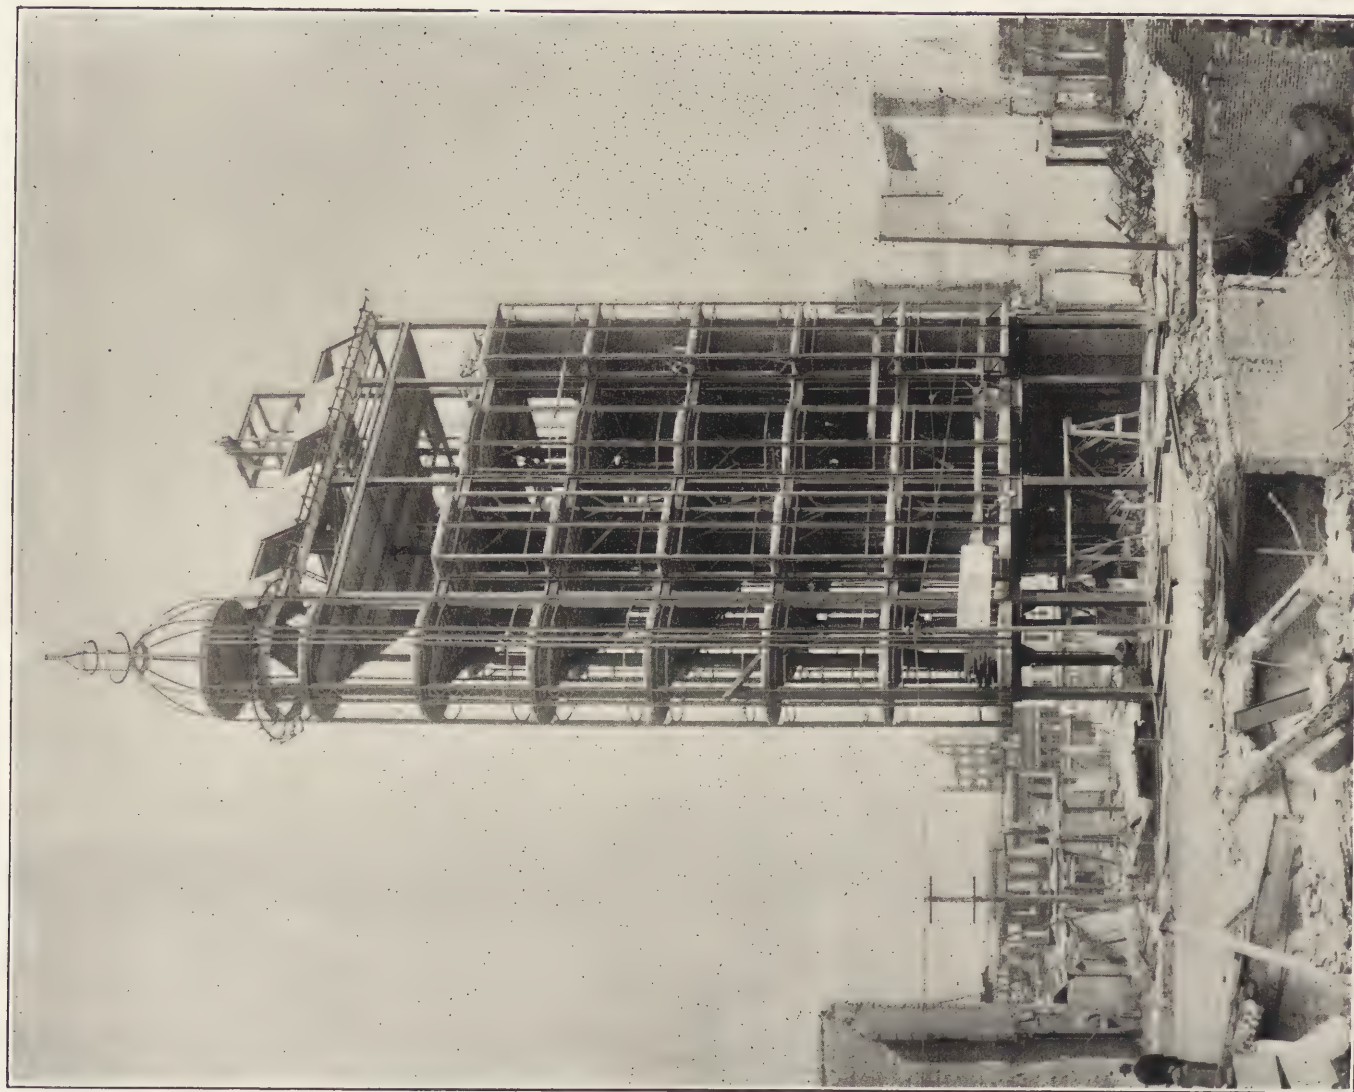
RUEFF BUILDING. Junction Montgomery Avenue and Kearny Street. This building was in course of construction, with the steel frame and fire-proof floors completed. Only a portion of the rear brick wall has been carried to the sixth story. The Roebling fire-proof floors and the steel frame are uninjured. This building sustained no serious structural damage from the earthquake or the burning of adjacent buildings.

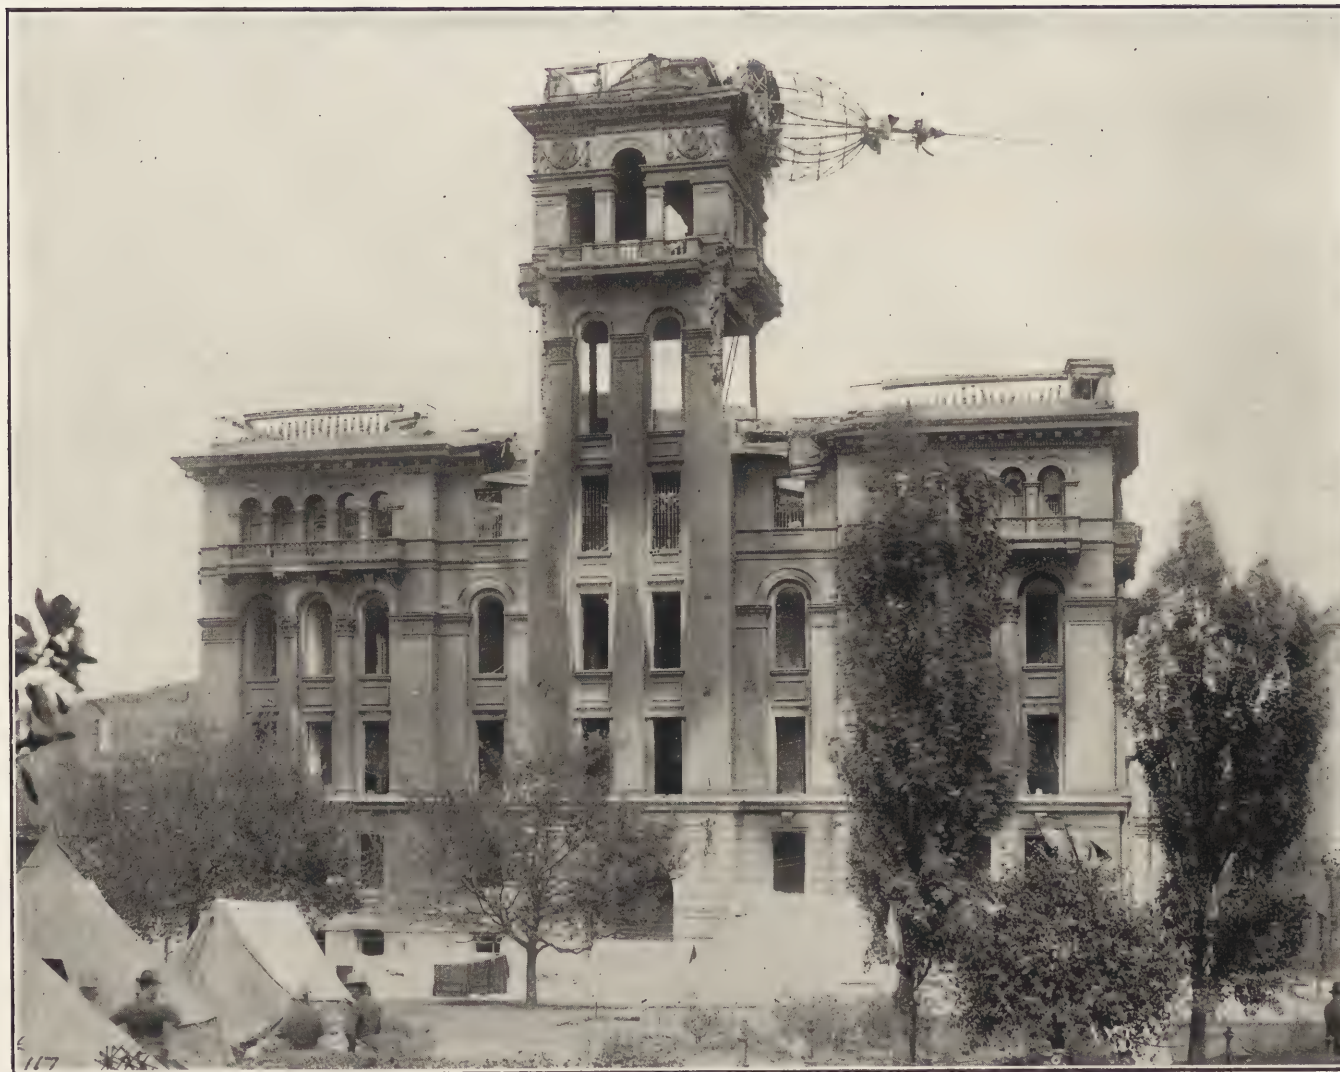
HALL OF JUSTICE. S. E. Cor. Kearny and Washington Sts. The façades consist of Colusa sandstone for the first story, and buff terra cotta brick and terra cotta ornaments above. The front of the building, excepting the tower, cornice and balustrade parapet, is but slightly damaged. The entire rear portion of the building and the tower are wrecked. The dome over the tower was of light steel framing, covered with galvanized iron. When fire entered the tower, the light steel members quickly failed, causing the dome portion to fall over in a horizontal position. Most of the damage to the mason work of the tower was caused by the earthquake.

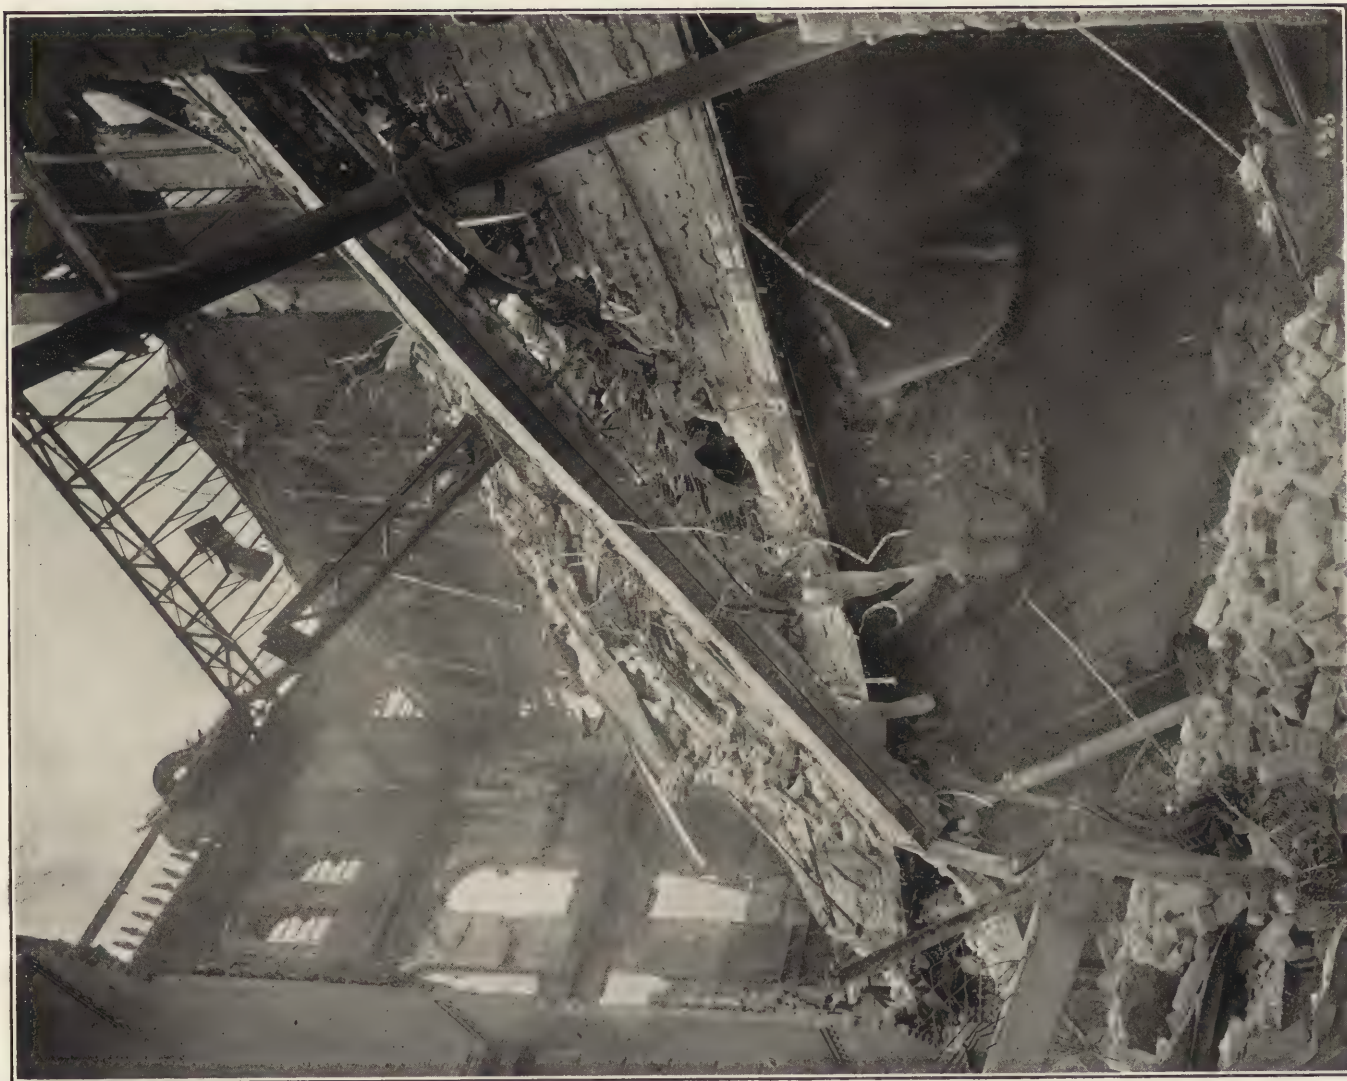
HALL OF JUSTICE. From the alley at the rear, looking into the rear half of the building which was wrecked. The suspender system of expanded metal floors was used in this building. This view shows the partial failure and sagging of the first floor arches under a heavy overburden of *débris*. In the upper stories the suspender bands are hanging in a vertical position from the parts of the building that remain standing. The rear wall was only 8" thick between pilasters and was about 60 feet high. Lime mortar of poor quality was used in this building.

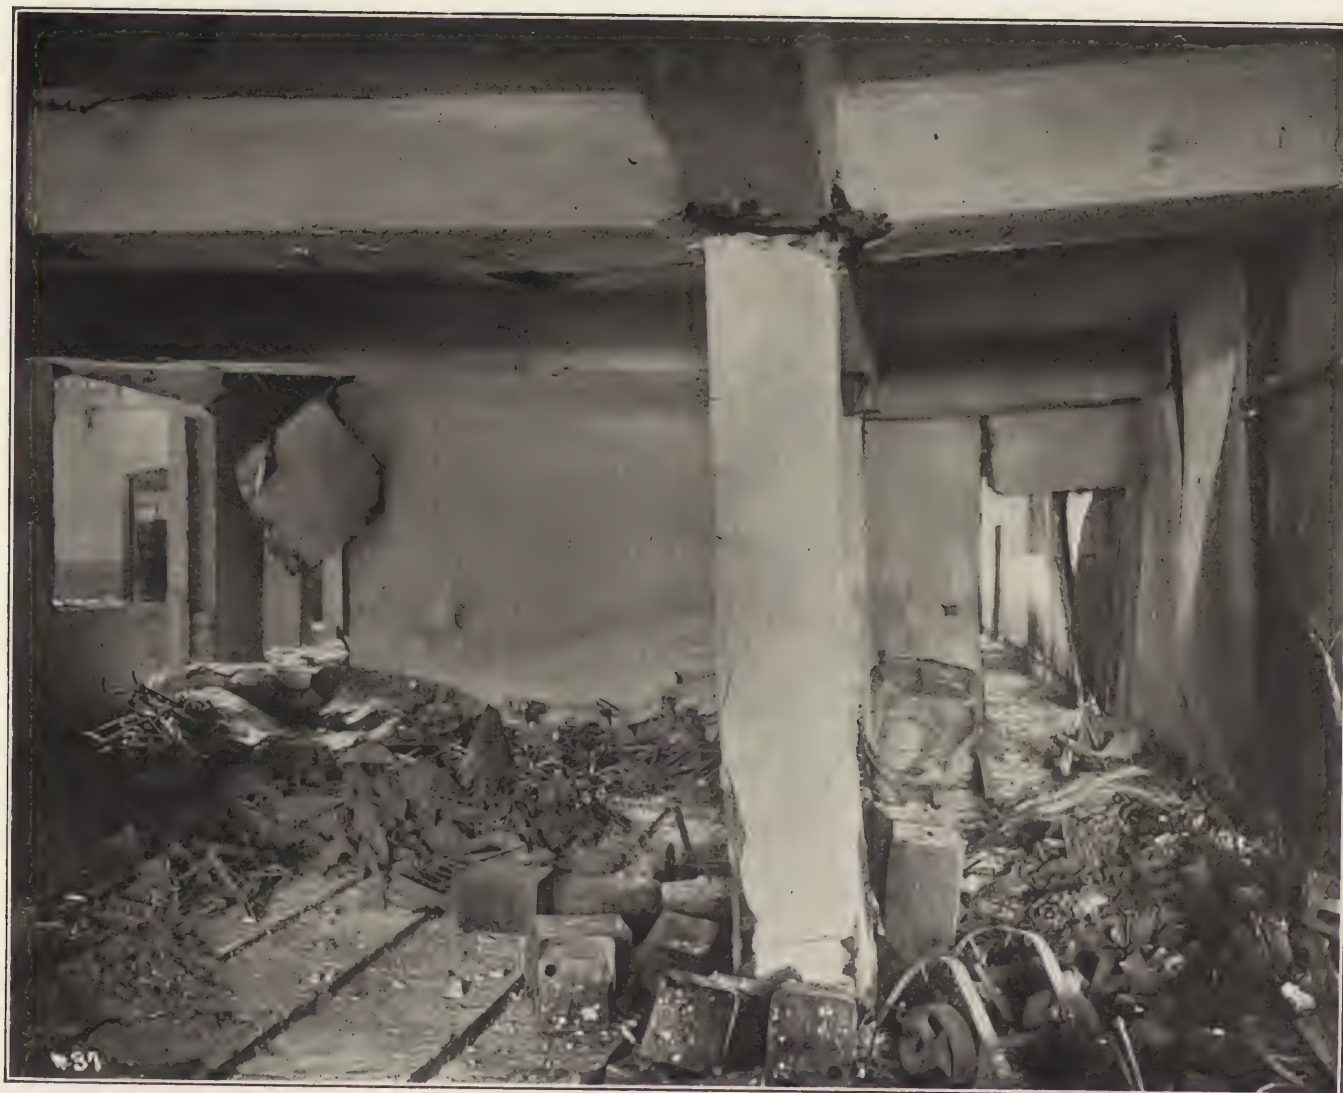
HALL OF JUSTICE. Basement Story. Showing a buckled column in the foreground, with disrupted expanded metal lath and plaster protection still adhering to it. This view was taken in the property room, showing stolen goods that were to be used as evidence in cases against prisoners. The prisoners' cells were located in the top story. The ceilings and partitions are of expanded metal lath and plaster.

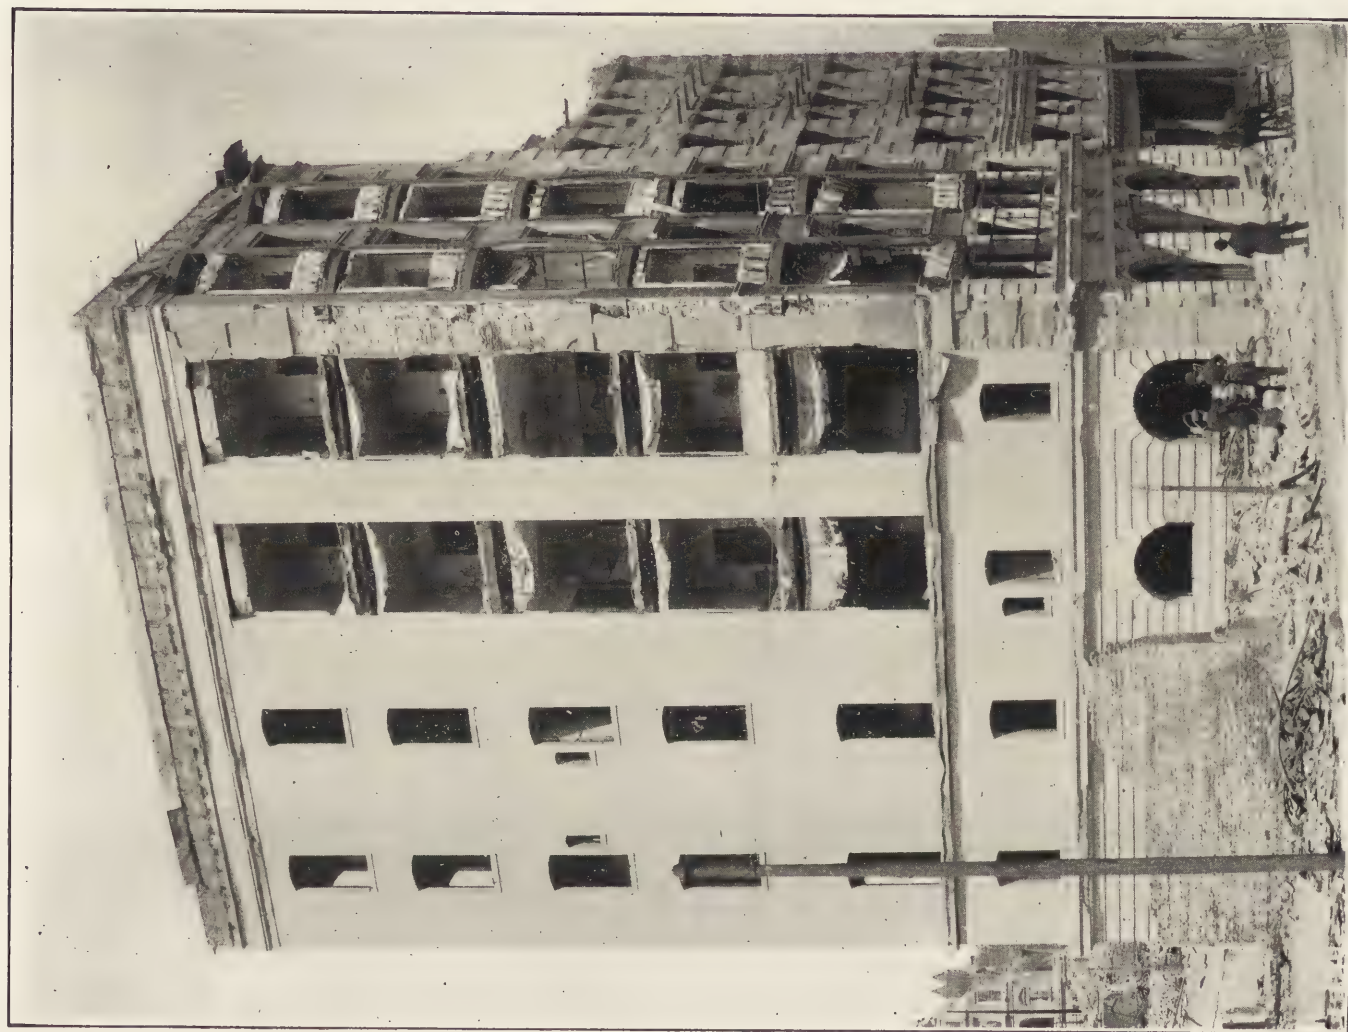
TURKISH BATHS. 632 Post Street. Excepting the southwest corner, which is badly cracked and spalled, the terra-cotta façade is but slightly damaged. A few earthquake cracks are visible in all the walls. There is a buckled column in the second story near the centre of the building. The bay windows were of wood construction. The cinder concrete floors remain in good condition. The metal lath and plaster ceilings, partitions and column covering are considerably damaged, but remain in position.

The repairs to the exterior of this building will be comparatively light. The replacing of the buckled column should not be a very serious matter. The rest of the repairs are limited to the restoration of the interior finish.

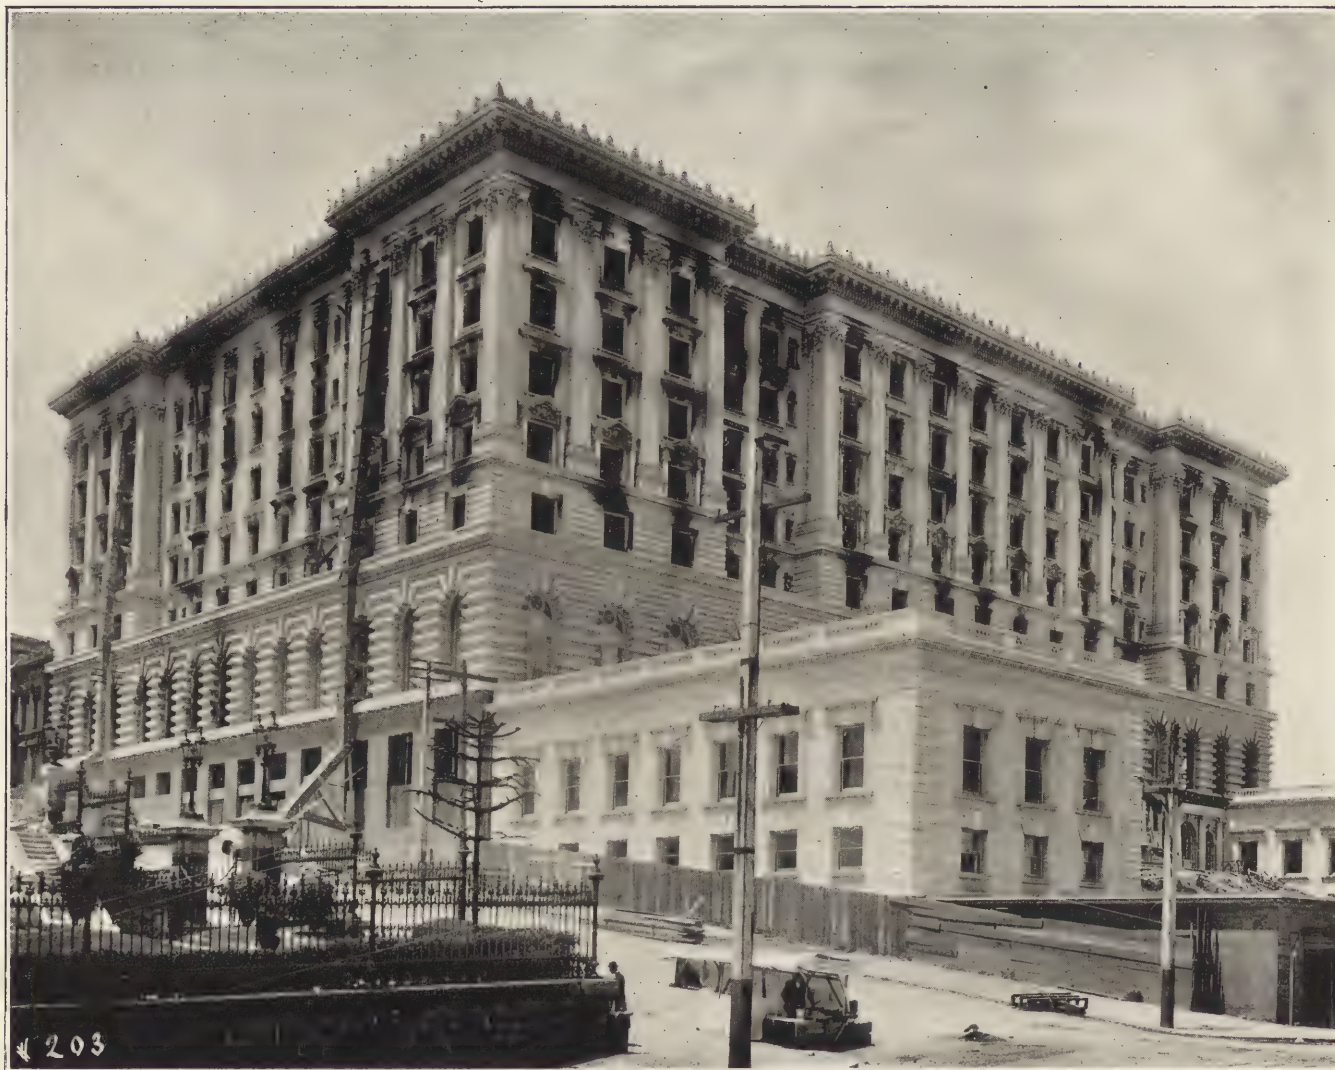
FAIRMONT HOTEL. Powell, Sacramento, Mason and California Streets. The façades, consisting of gray granite for the first story, and cream-colored terra cotta above, are but slightly damaged. The terra cotta around some of the window openings is spalled, and at the third-story level of the east side considerable damage has been wrought by the earthquake. The interior of this building is in bad condition on account of the buckling of between 30 and 40 columns, causing the floors to have a wavy effect and buckling and distorting the partitions in the upper stories. The buckling of the columns was caused by insufficient fire protection, many of them being simply within blind spaces enclosed by expanded metal lath and plaster partitions, and without independent protection. The metal lath and plaster ceilings fell in many places; on account of a weak wire clip which was used to support them. Notwithstanding the warped and distorted condition of the steel work, not a single span of the expanded metal concrete floors dropped out. Repairs to the exterior will be comparatively small, but almost the entire interior will require reconstruction.

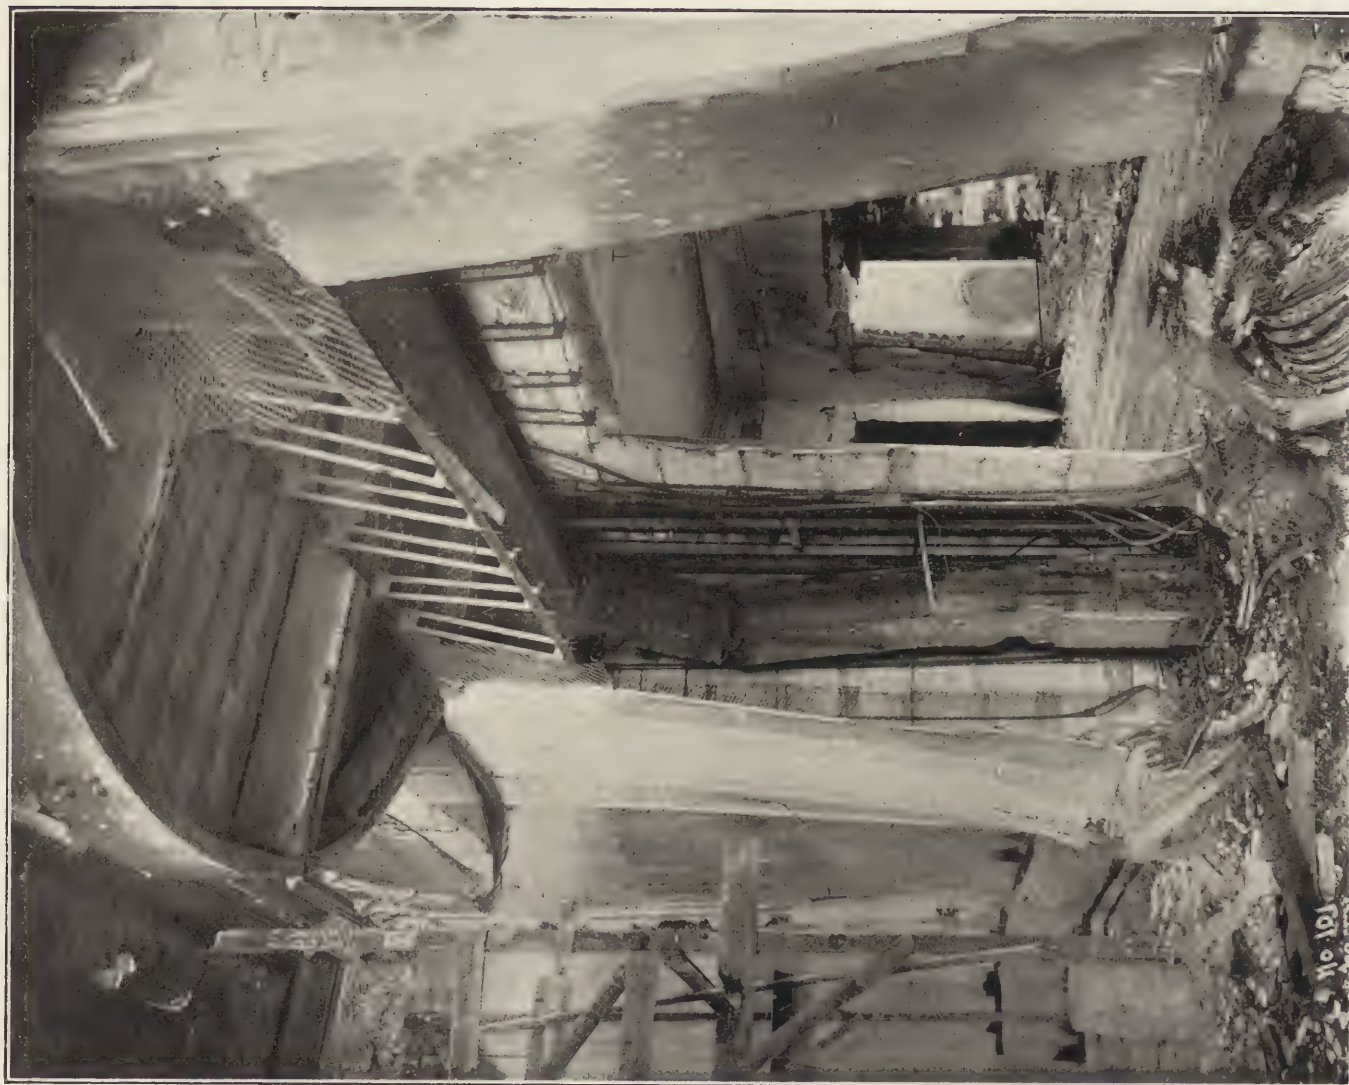
FAIRMONT HOTEL, First Story. From the ball room, looking through the doorway into the corridor. Showing a buckled column that was simply enclosed in a large blind space between partitions. The latter were nowhere less than 18" away from the column. The settling of the column deflected and buckled the partitions as shown.

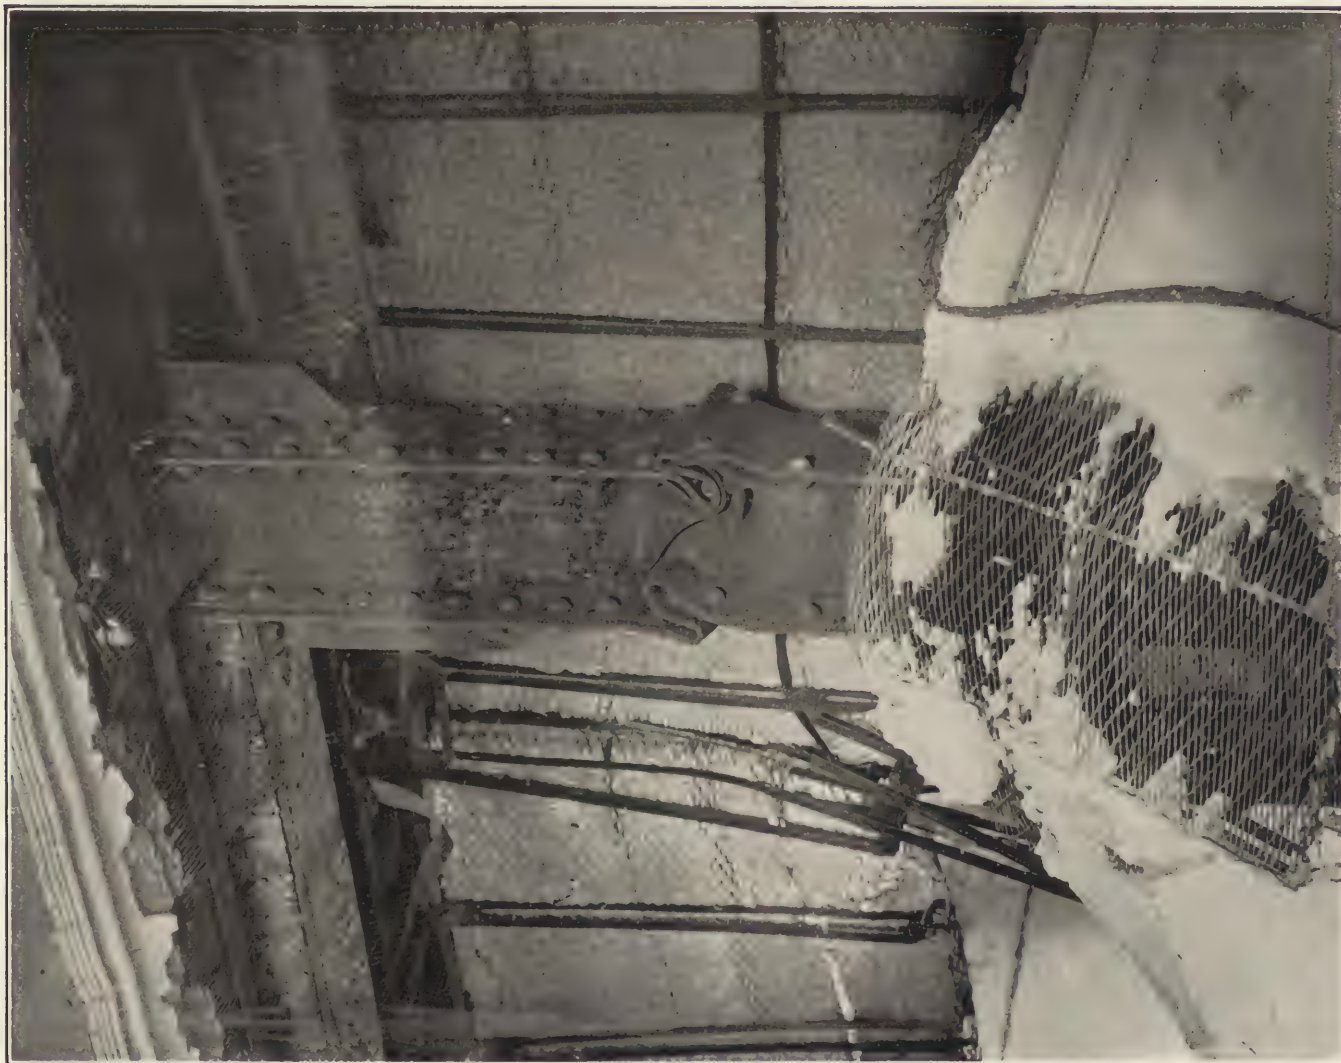
FAIRMONT HOTEL. Third Story. Showing a badly buckled column, which was simply enclosed between metal lath and plaster partitions without independent protection. The partition leaning against the lower half of the column originally stood along the line where the plastered cove is ruptured at the ceiling.

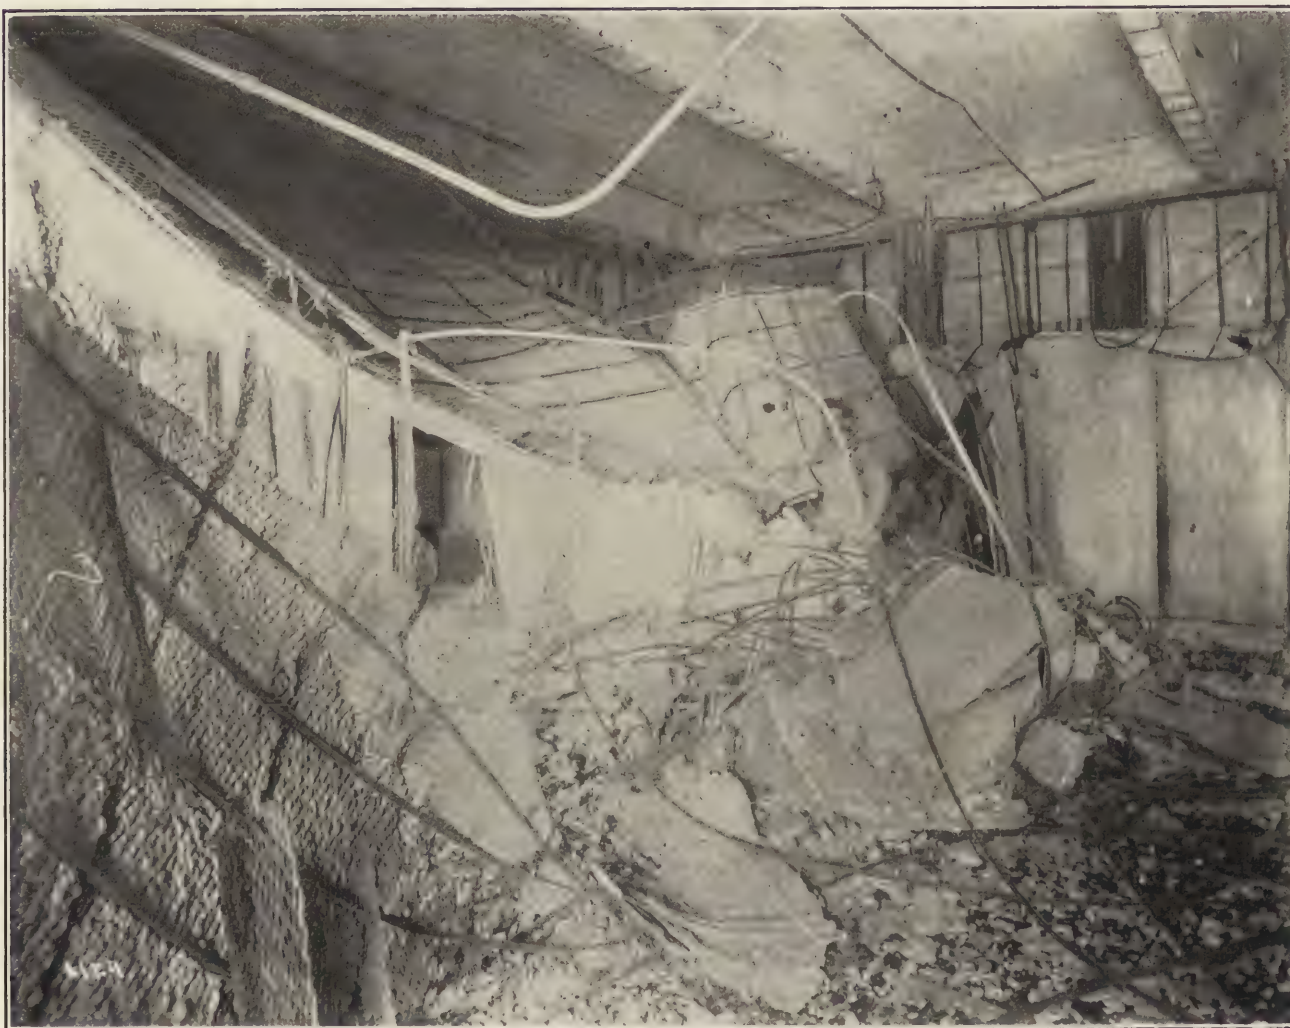
FAIRMONT HOTEL. Third Story. Showing the failure of the flat expanded metal lath and plaster ceiling, due to the use of wire clips for supports from the beams. The section of the wire clip is so small that it is quickly heated and weakened so as to permit the ceiling to fall away. Note the column in the rear, which was protected by simply building a pilaster around it, projecting from the partition on one side and without light steel furring or other methods of anchoring the protection to it.

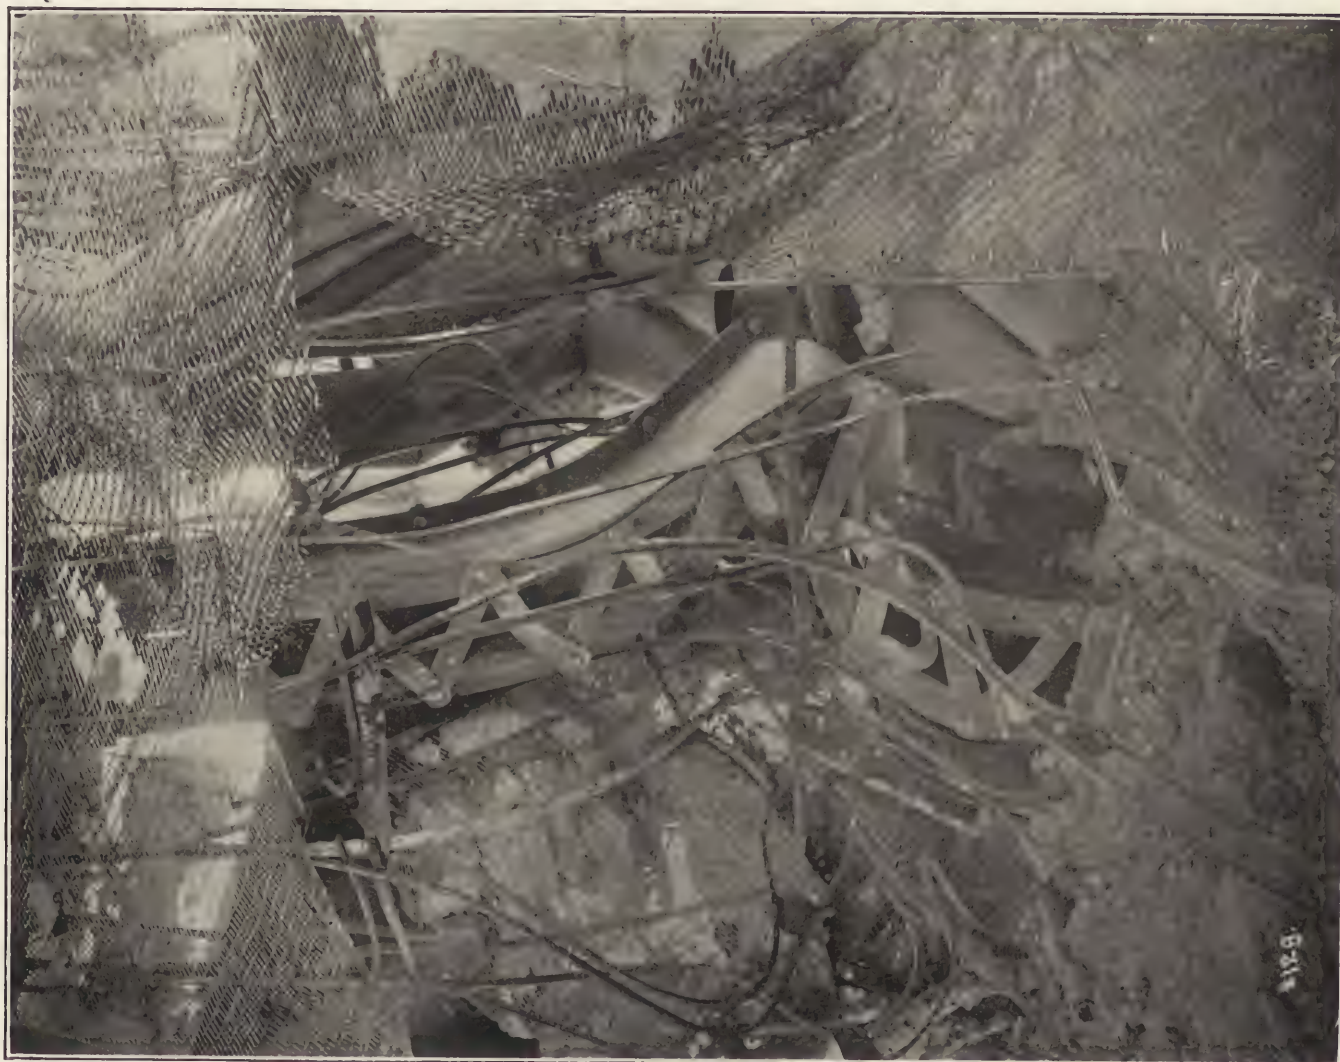
FAIRMONT HOTEL. Fifth Story. Showing a badly buckled, latticed channel column. The protection consisted of 4" solid expanded metal lath and plaster partitions built around it. Note also the buckled piping which was enclosed in the same space with the column.
